## ***Easy-Laser® Success Story: Proper Alignment Will Reduce Your Carbon Footprint***

***By Benchmark Maintenance Services, Inc.***

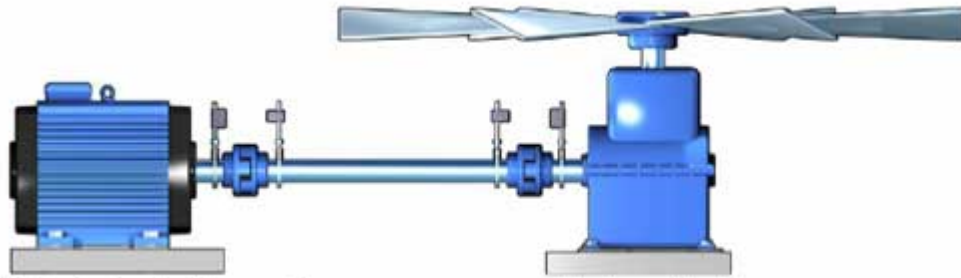
**Both jack shaft couplings are measured when the laser cannot span the required distance.**

One example is Lake Erie Steel, a large steel mill in Nanticoke Ontario, who recently purchased an EASY-LASER®, dual beam, shaft alignment system. This system gives them the ability to align the 14 foot long Jack Shafts on their water cooling towers. Spanning the 14 feet coupling to coupling is not a problem for the Easy-Laser® that is capable of shaft alignment over a distance of sixty feet. In the past a contractor had done this work using a single beam system that could not span the required distance of fifteen feet from the motor to gearbox. The procedure for this type of system had been to measure alignment at each coupling on either end of the Jack Shaft and then use both sets of alignment results to calculate the necessary correction in order to align the machine units.

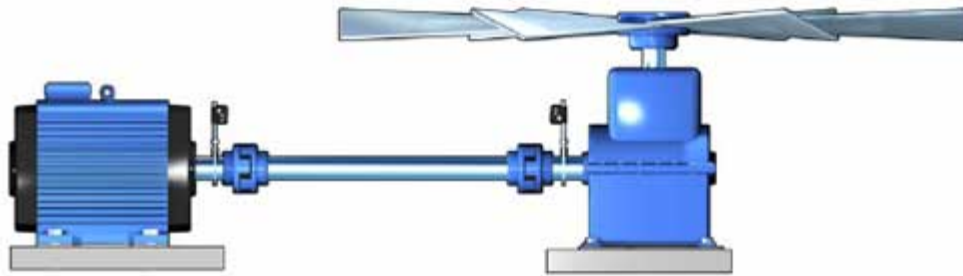
Measuring directly from motor to gearbox shafts

Then by simply using the laser beams which were centered in the closed target at the 9 o'clock position the shaft was then rotated to the 3 o'clock position. This is a very quick and easy procedure that is used when doing rough alignment for jack shafts. It determines immediately if the machine is out of alignment and the proper movements for correction. In this case it showed that the alignment was grossly out so corrective action began. Measuring directly from motor to gearbox shafts

Now with the laser target doors open, measurements were recorded in as little as forty degrees of shaft rotation. The display showed real time readings in both the horizontal and vertical planes for the moveable machine. The moveable machine is usually the motor however it is possible to change the configuration of the machine in the laser display if the driven (Gearbox) unit is to be moved or even a combination of different machine feet. The trick is in choosing the correction that requires the least amount of movement. Now all that was needed was to re-position the machine but the real skill was in controlling the movement. At a distance of fifteen feet you don't bump anything; it's a gradual move which is best done with jacking bolts. The work was completed and unit was put back in service.

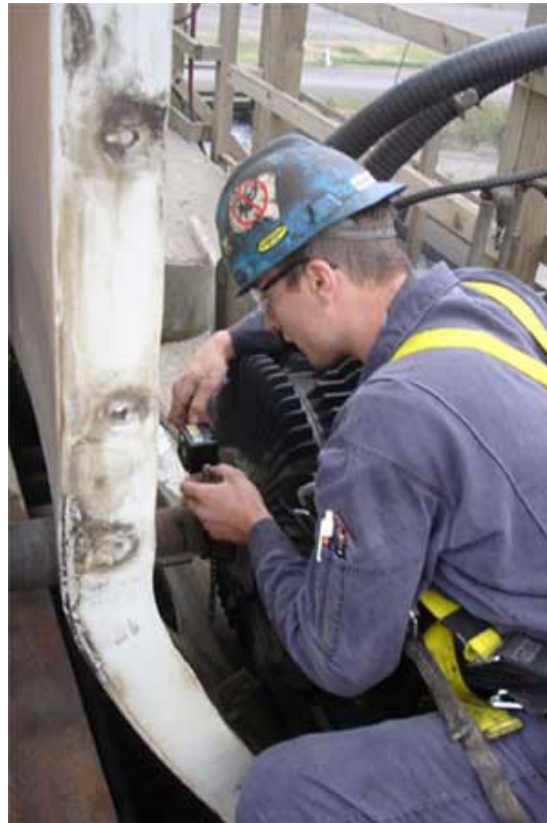
One Laser/Detector is mounted on the motor shaft which is outside the cooling tower wall.

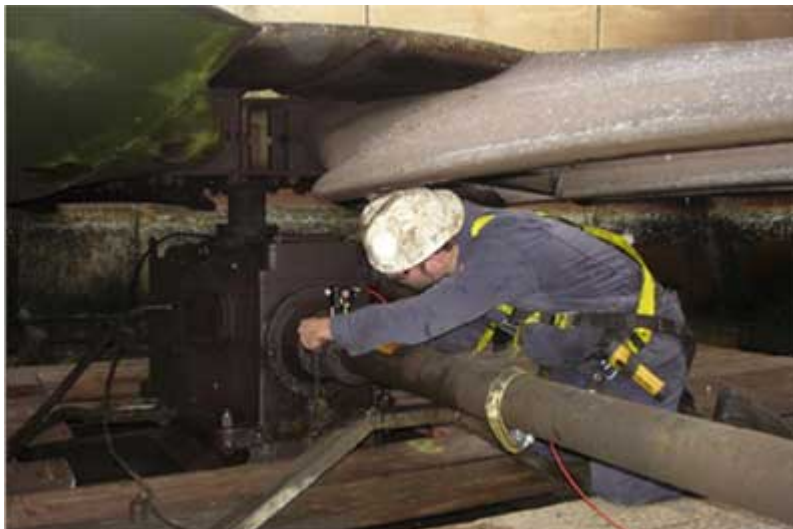
There is not much room under the large fan blades for the apprentice but the other Laser/Detector is mounted on the Gearbox shaft.

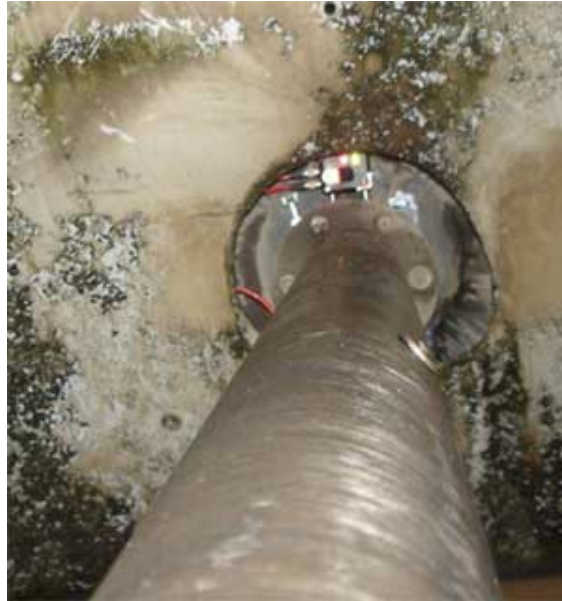
The laser beam from the motor shaft passes through the opening in the cooling tower wall.

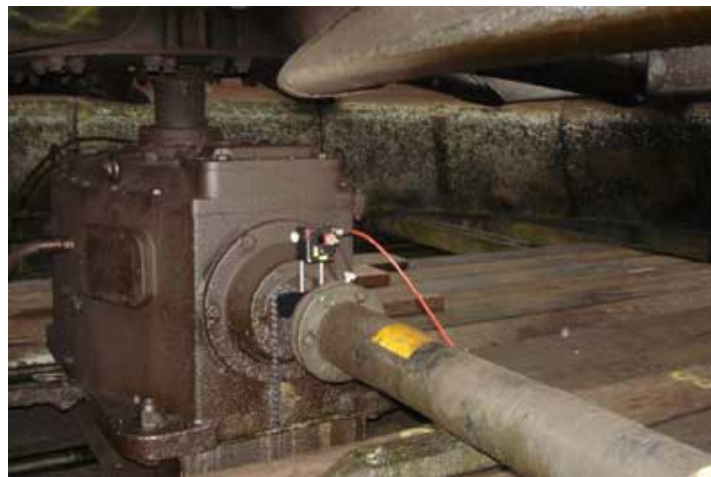
The beam hits the detector that is mounted on the gearbox for shaft to shaft alignment.
